Annual Inspection

Whaddon Parish Council

Whaddon Play Area
Shenley Road, Milton Keynes , MK17 0LW

Inspection Ref: 2432078

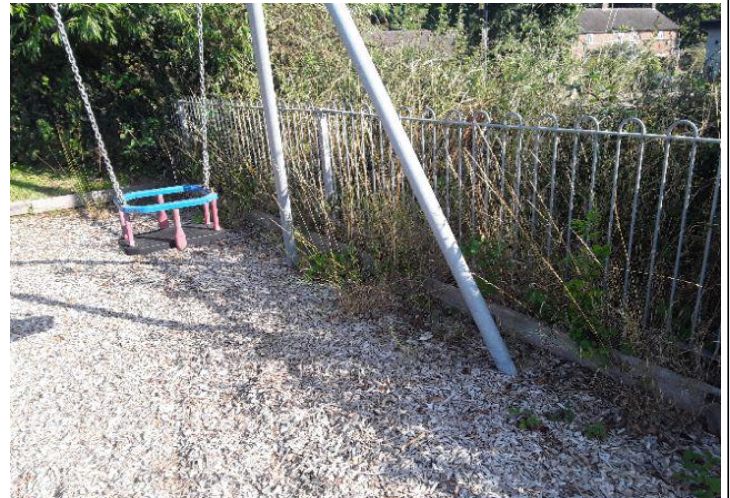
Finding: There is weed / vegetation growth on, between, or around the edges of the surfacing **Action:** Remove weed / vegetation growth

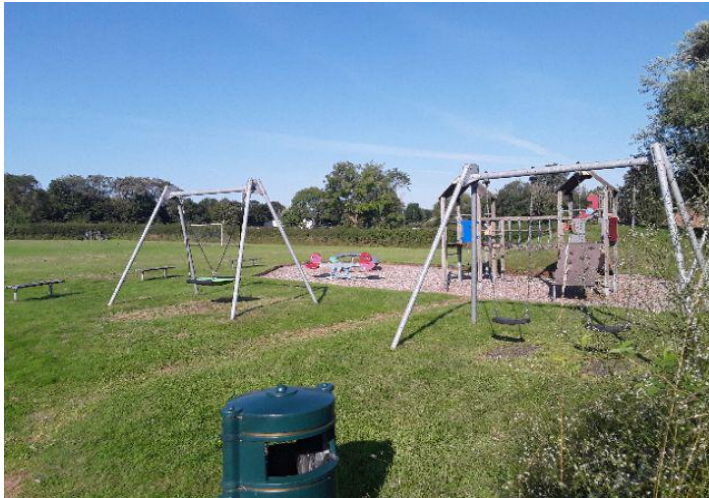
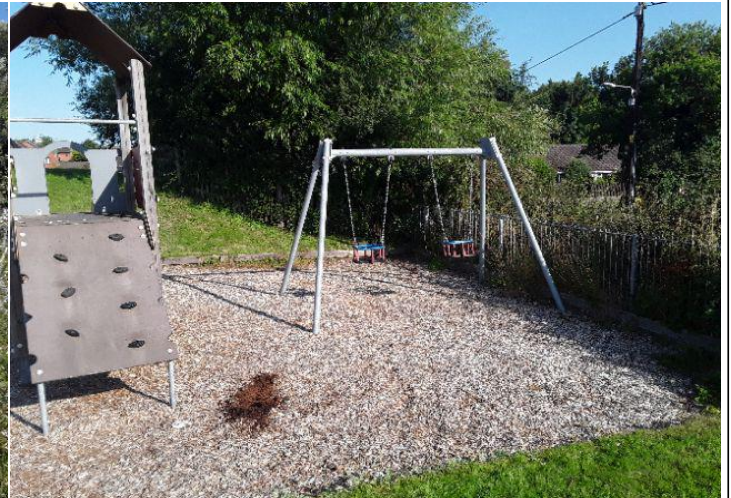
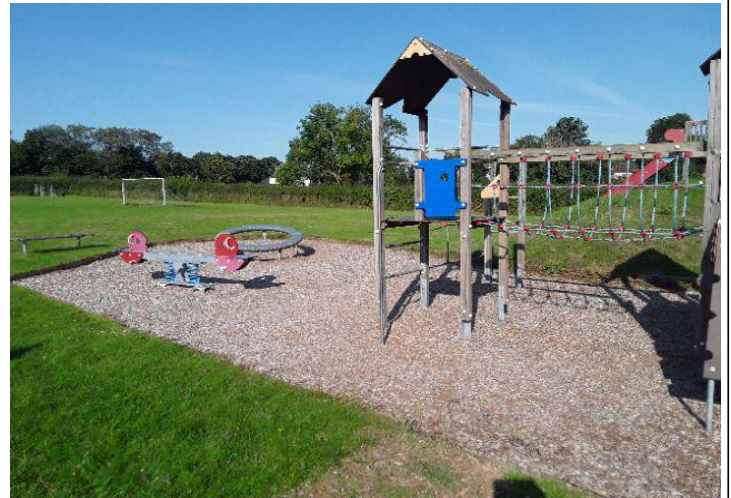
Finding: The depth of the loose fill surfacing is lower than the recommended depth specified in BS EN 1176; the free height of fall of the equipment is less than 2.0m and a minimum of 300mm depth should be provided (including an extra 100mm to allow for compaction and displacement as per BS EN 1176 Part 1 - Table 4)

Action: Top up loose fill surfacing to recommended levels

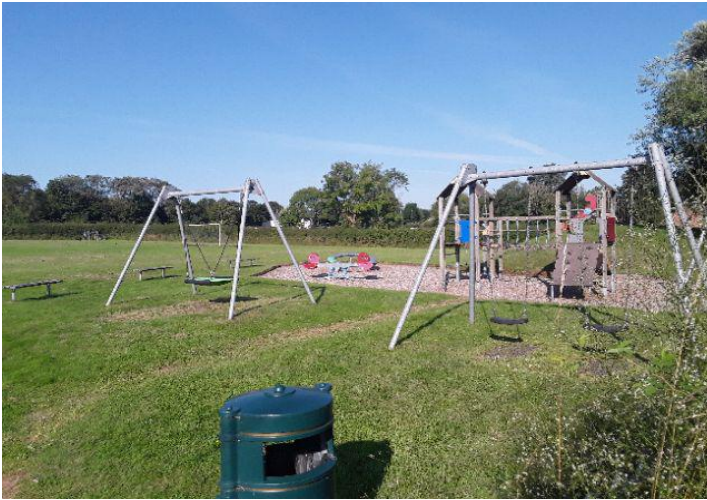
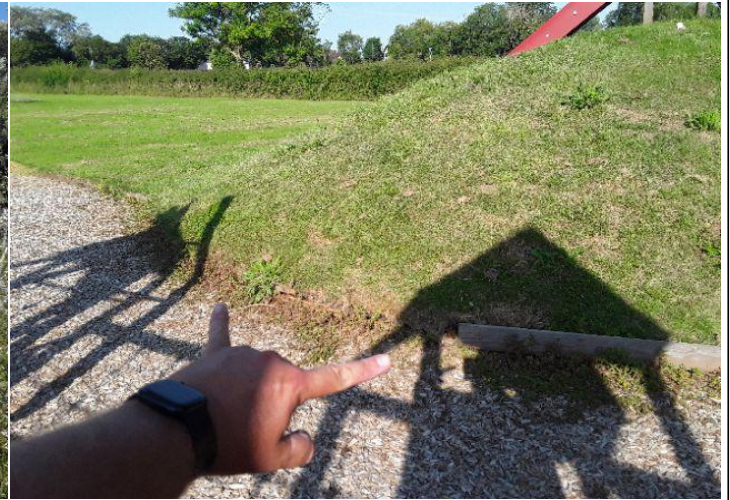
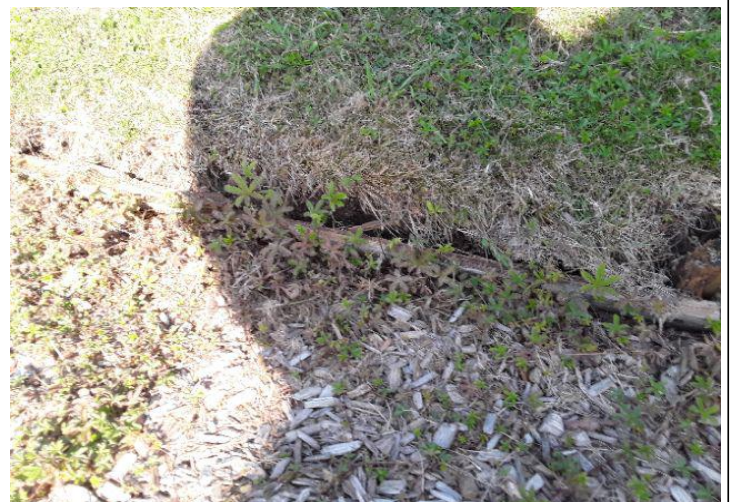
Finding: There are areas or parts of the timber edging that have rotted

Action: Replace all affected timbers

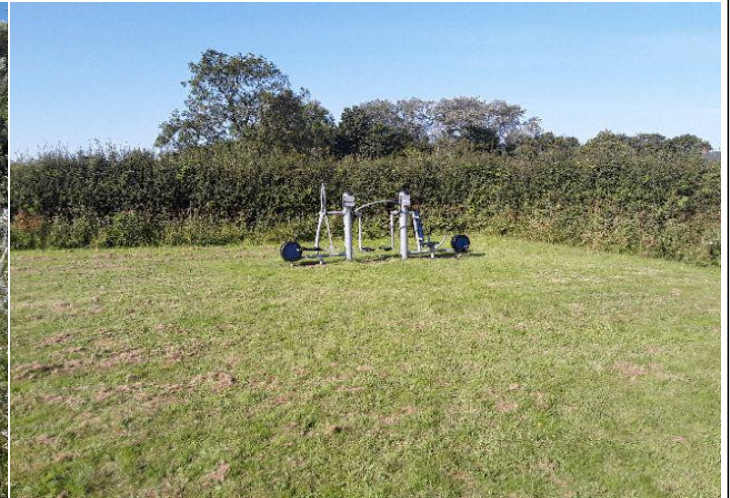
Finding: Signage should be provided for the outdoor fitness equipment in accordance with the requirements of BS EN 16630, key requirements of the sign include, but are not limited to, intended users, medical safety and emergency contact details
Action: Provide appropriate signage

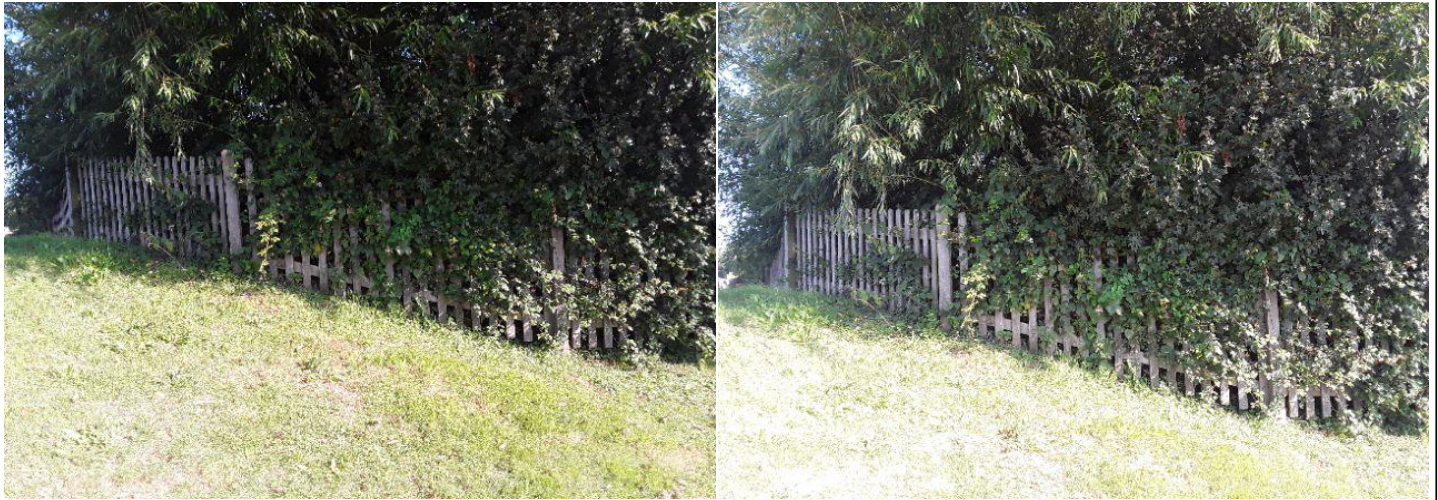
Finding: The adjacent foliage is overhanging

Action: Cut back and maintain

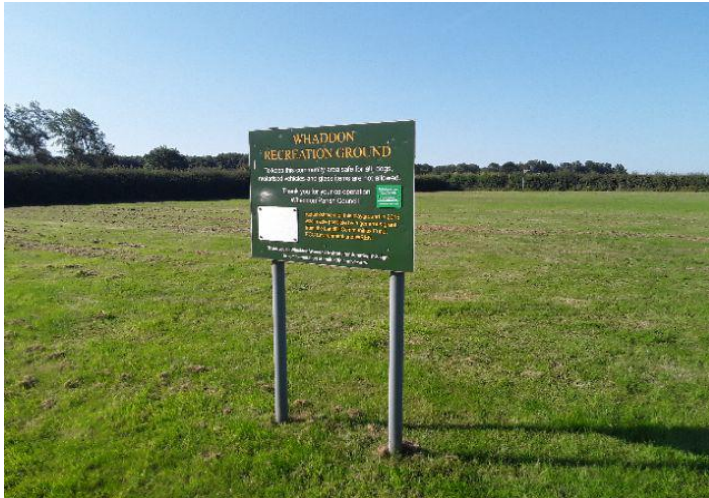
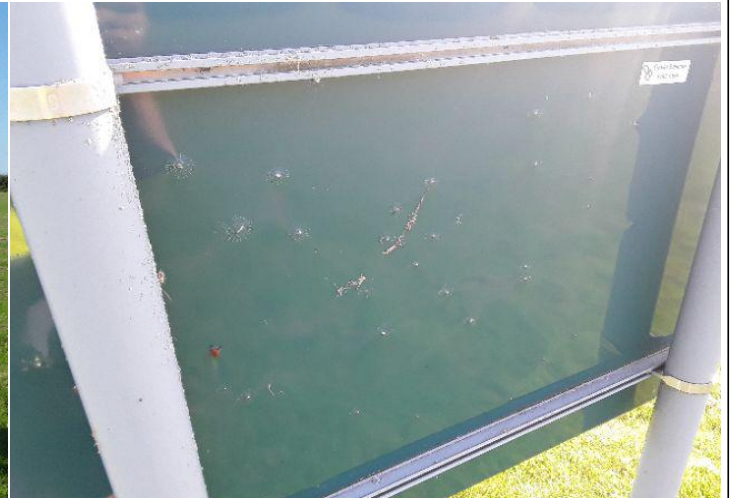
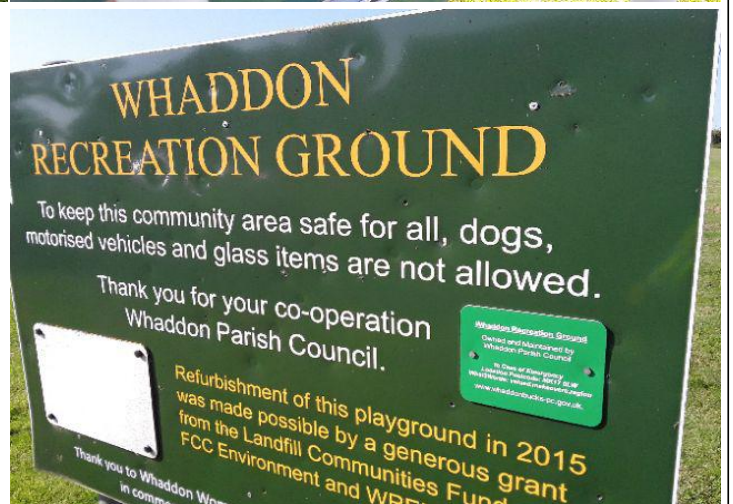
Finding: The item has been damaged

Action: Monitor for any further deterioration and replace as required

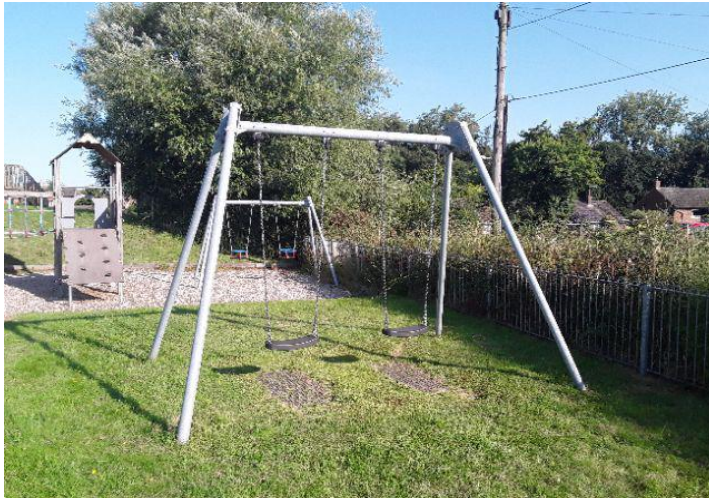
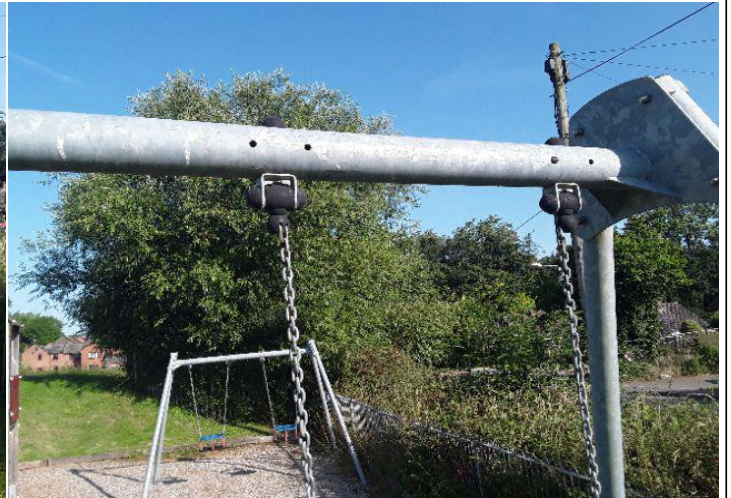
Finding: There is/are inserts missing

Action: Replace missing inserts

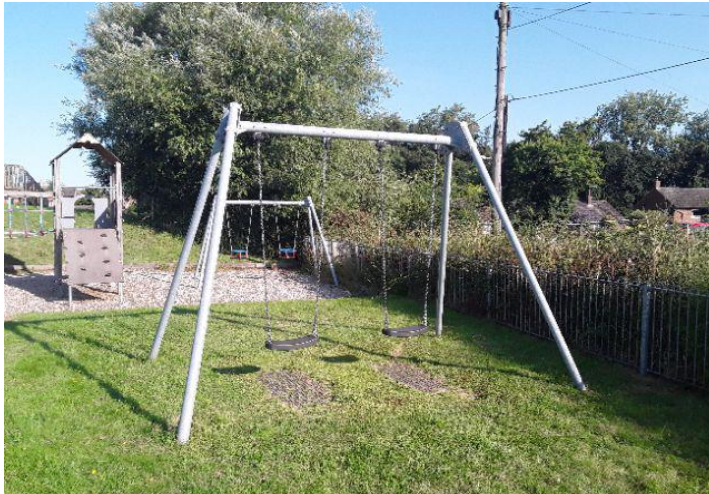
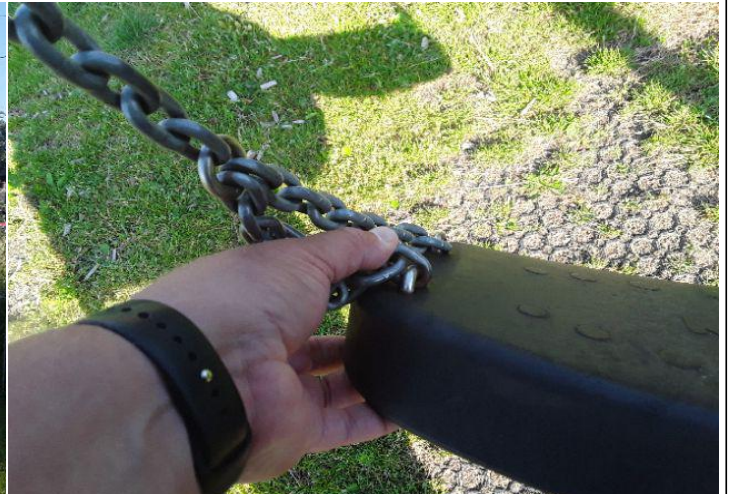
Finding: There is some notable evidence of chain wear

Action: Monitor for any further deterioration and replace when 40% worn

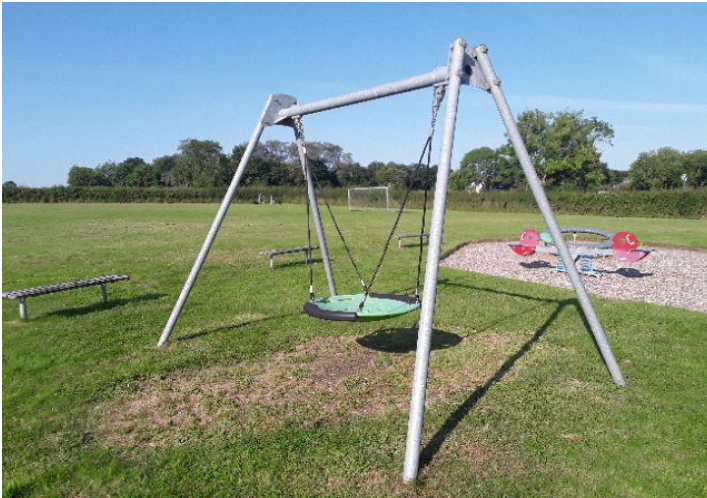
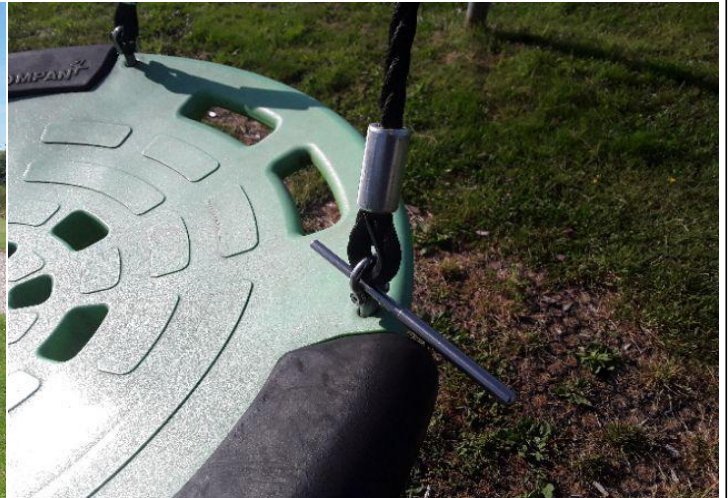
Finding: The connecting links are in excess of 8.6mm and less than 12mm and fail the requirements of BS EN 1176 Part 1; clause 4.2.13, Chains

Action: Monitor - No remedial work recommended

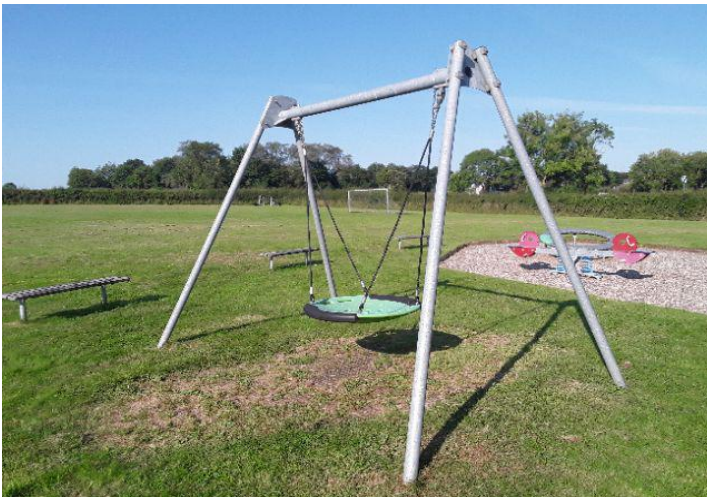
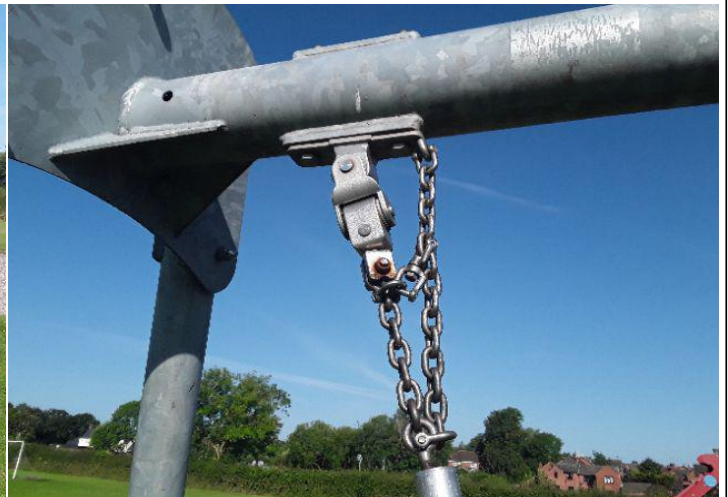
Finding: There is some notable evidence of chain wear

Action: Monitor for any further deterioration and replace when 40% worn

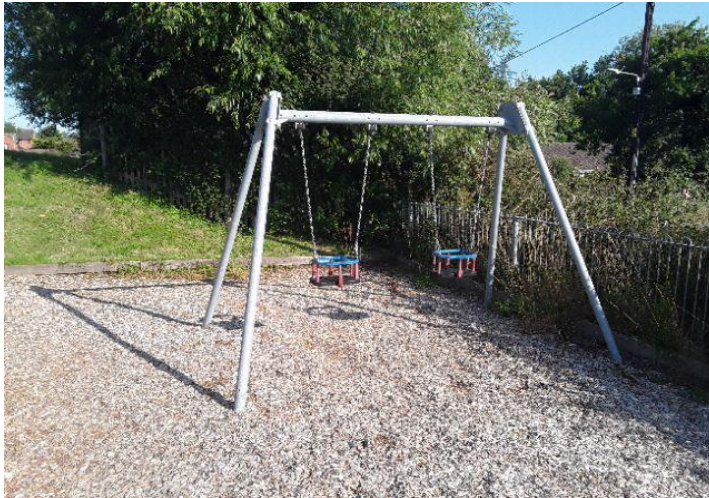
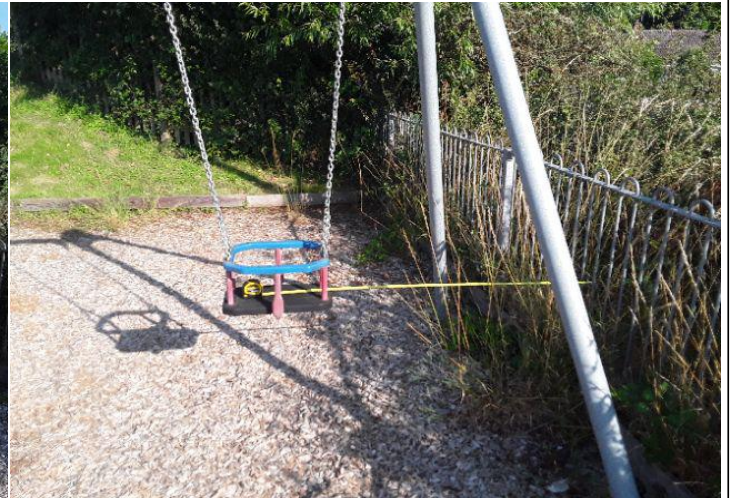
Finding: BS EN 1176 Part 2: Annex A makes a recommendation that fences or enclosures should be upto 1.50m from the edges of the swing seat to the sides, and subject to risk assessment, from the edge of the impact area. This is however, a low risk finding and no remedial action is recommended.

Action: Monitor - No remedial work recommended

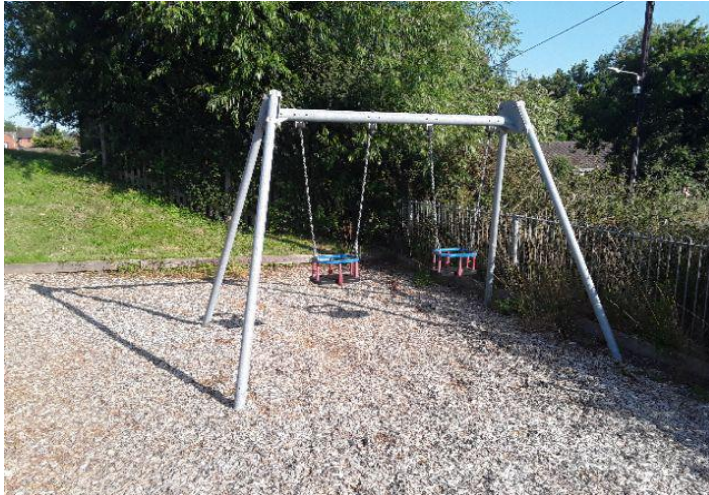
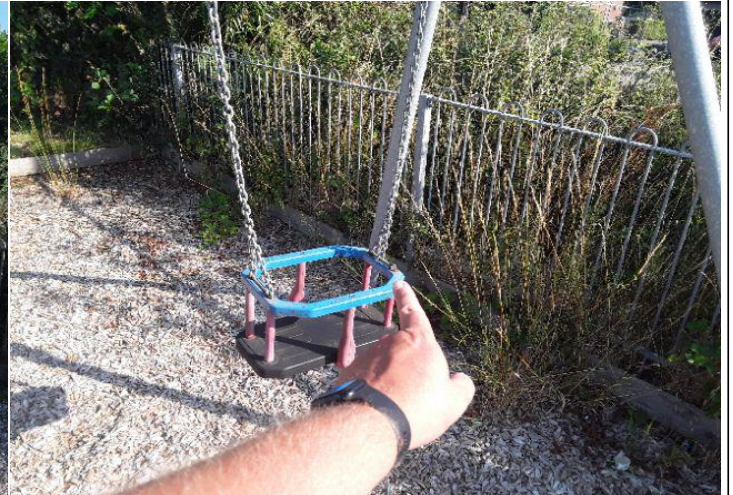
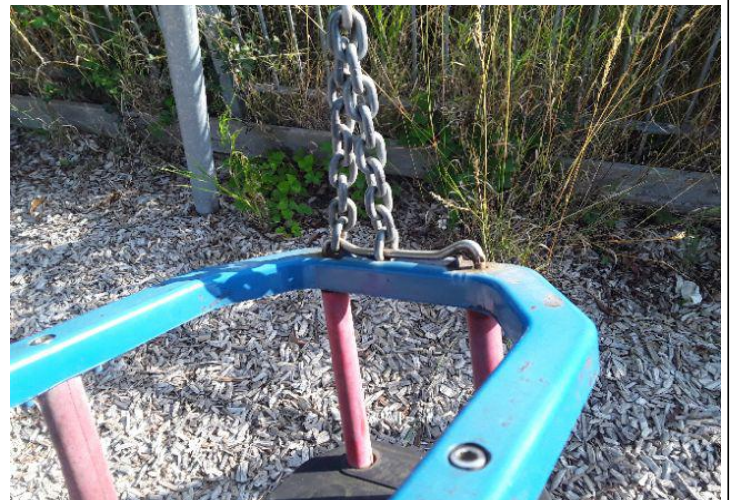
Finding: The swing seat connector is damaged and the chain is out of position

Action: Repair or replace

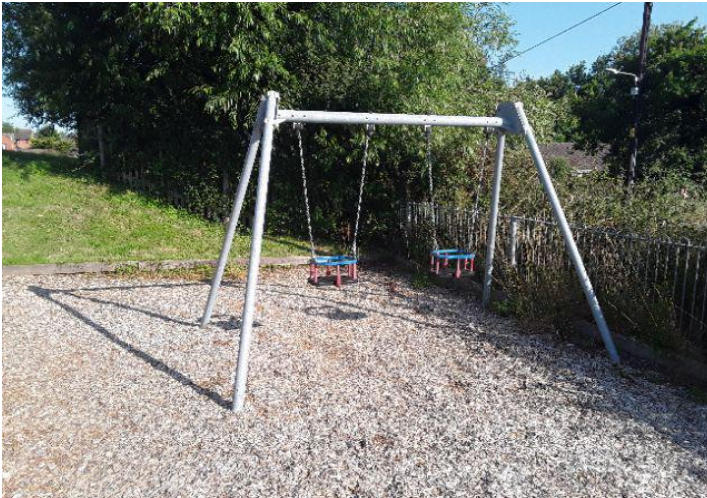
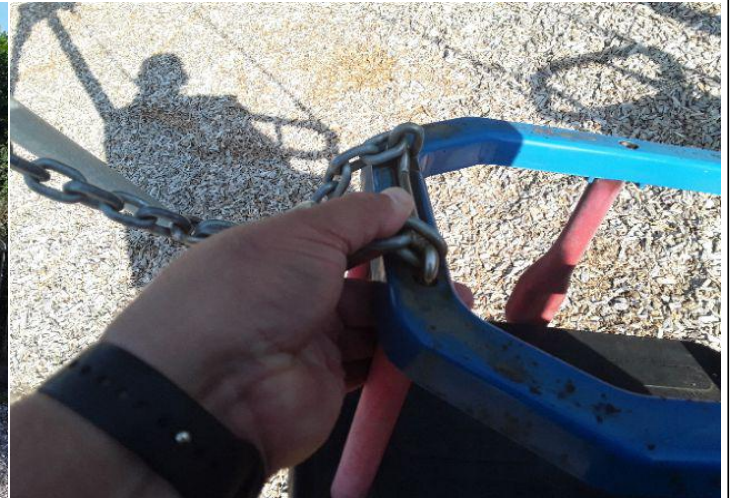
Finding: There is some notable evidence of chain wear

Action: Monitor for any further deterioration and replace when 40% worn

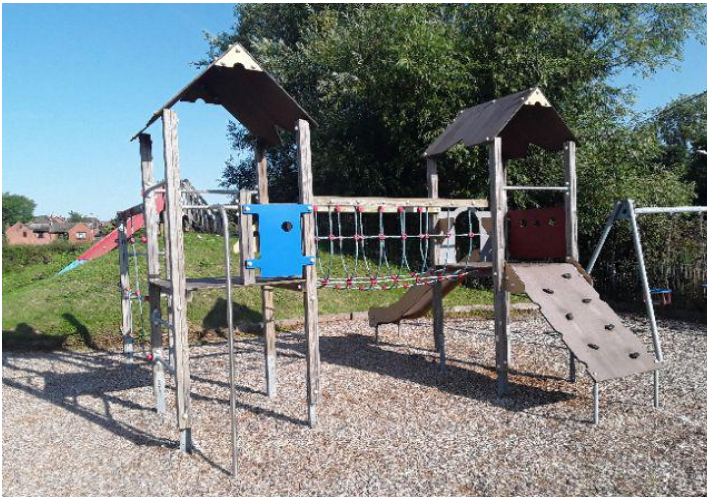
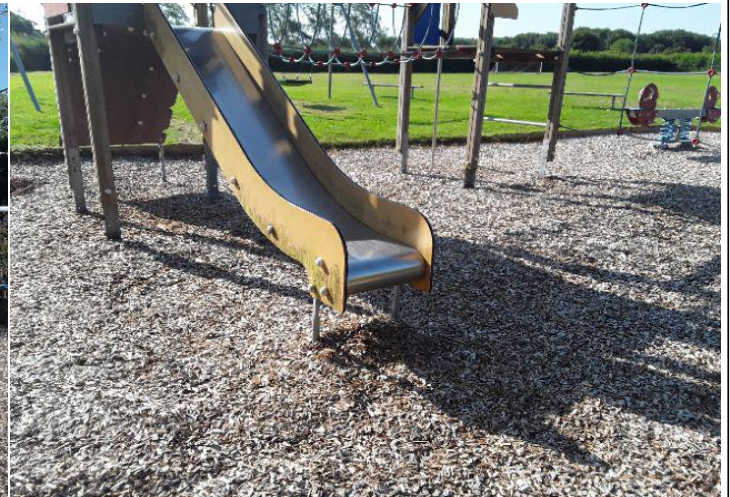
Finding: The height of the slide runout is in excess of 350mm and does not meet the requirements of BS EN 1176: Part 3

Action: Top up loosefill to recommended levels

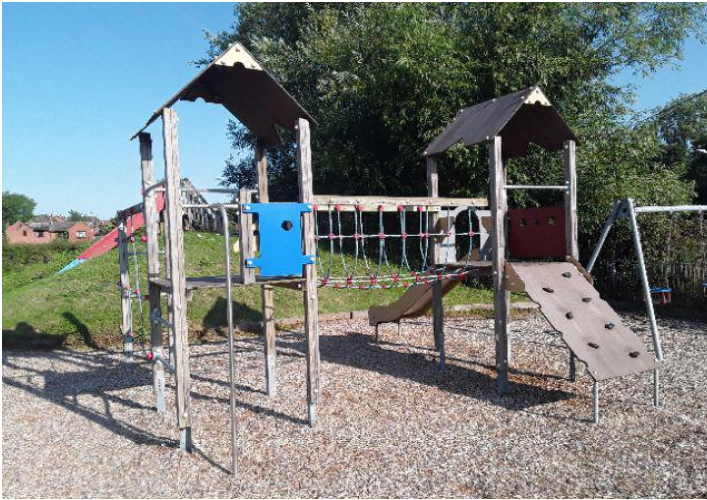
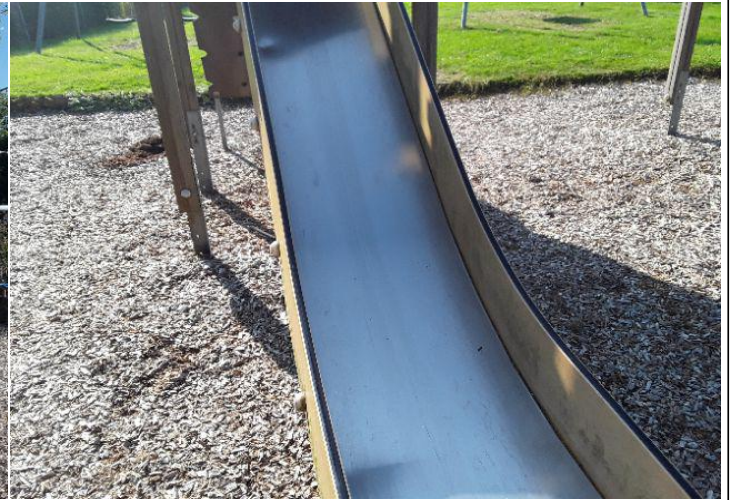
Finding: There are a number of dents in the slide surface

Action: Monitor for any further deterioration and repair as required

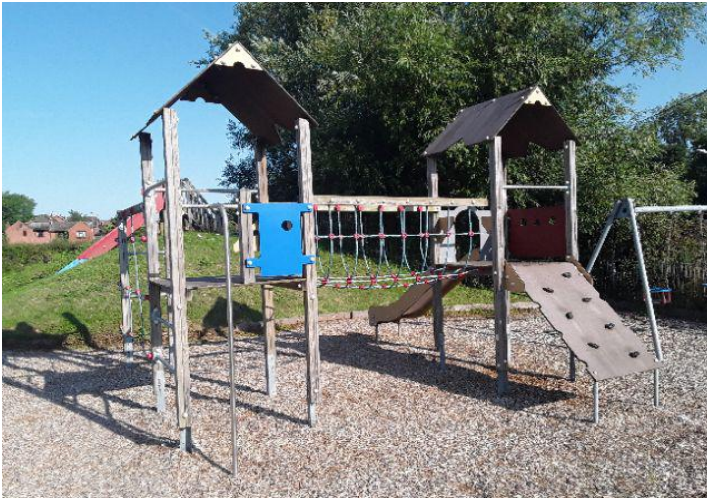
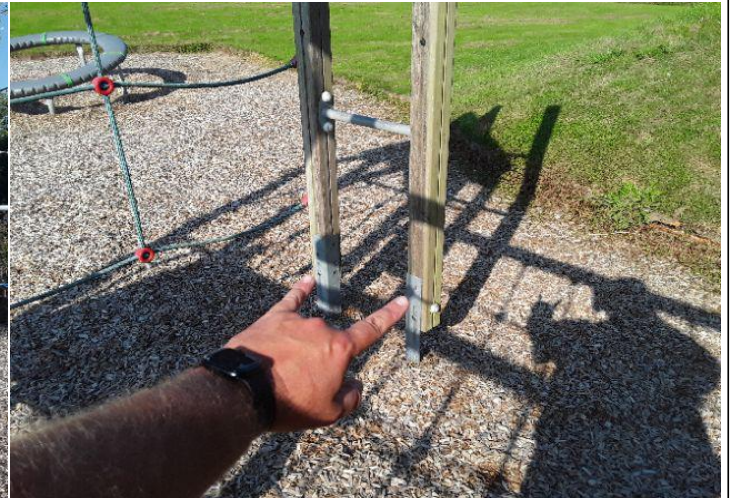
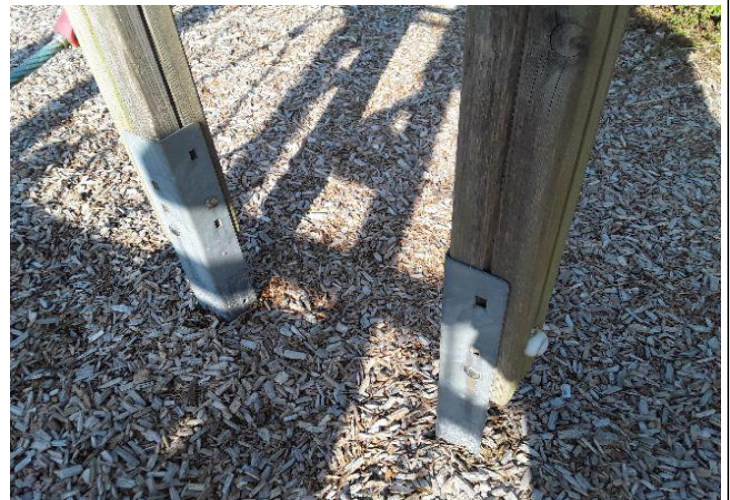
Finding: There is or are fixings missing on the post shoes

Action: Replace all missing fixings

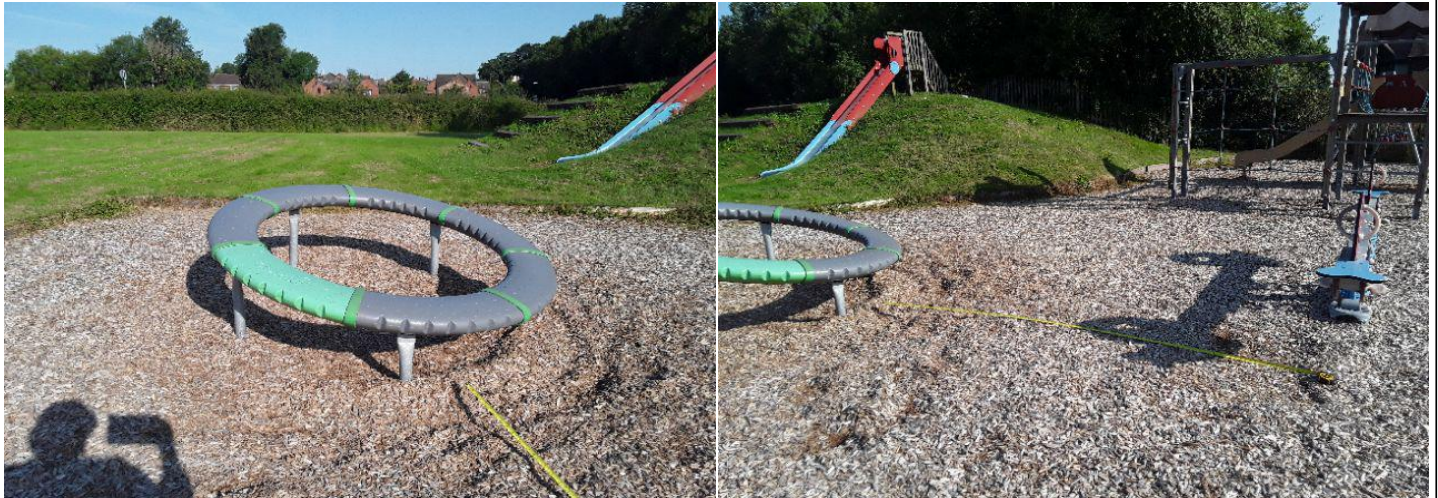
Finding: The falling space overlaps the free space between the item and the supernova in contravention of the requirements of BS EN 1176:2017 Part 1
Action: Monitor - No remedial work recommended

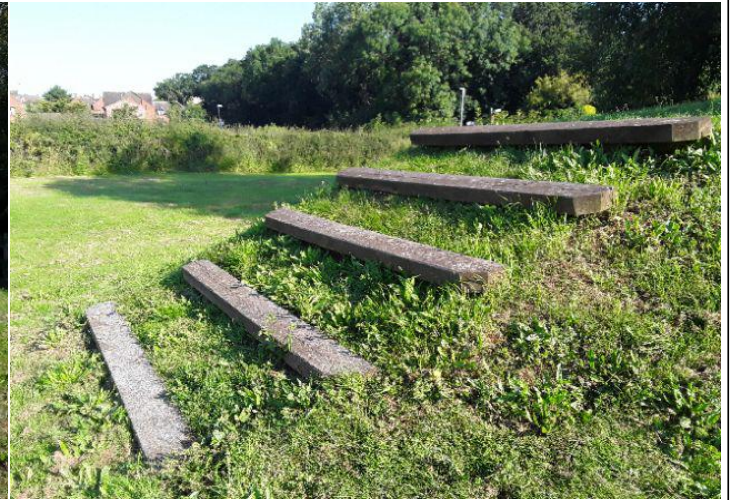
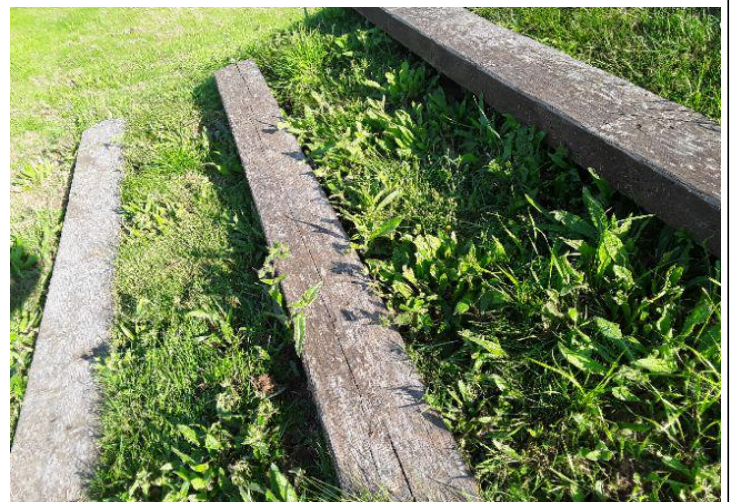
Finding: The steps protrude and are uneven creating trip points

Action: Reinststate the surrounding surface to remove trip points

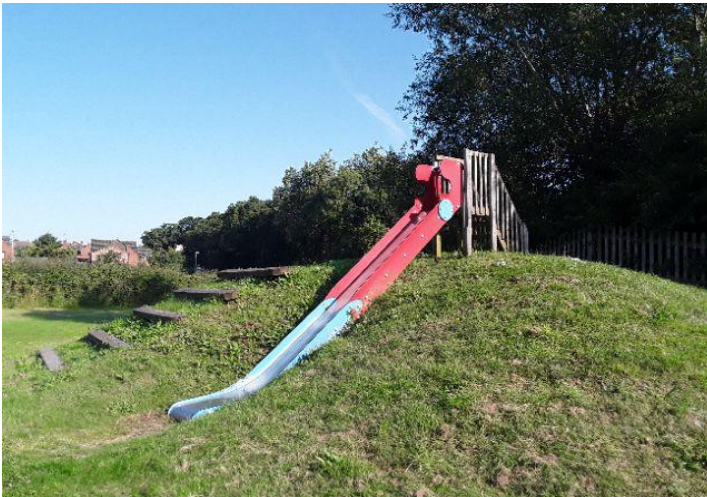
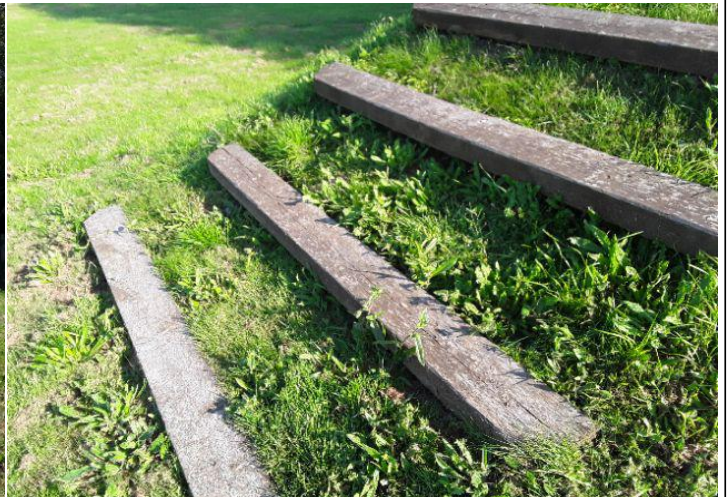
Finding: The timber has a number of splits/shakes or air cracks and this may affect the stability or allow water ingress which will accelerate the rotting process

Action: Monitor to ensure the splits do not cross through fixing points of the structure and/or cause any instability

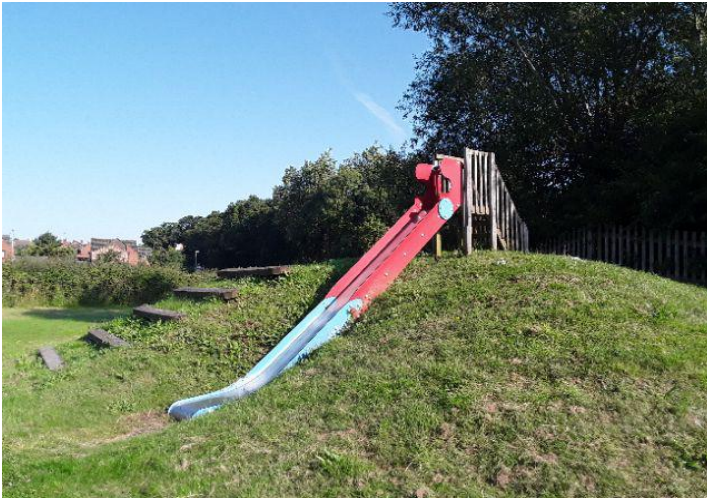
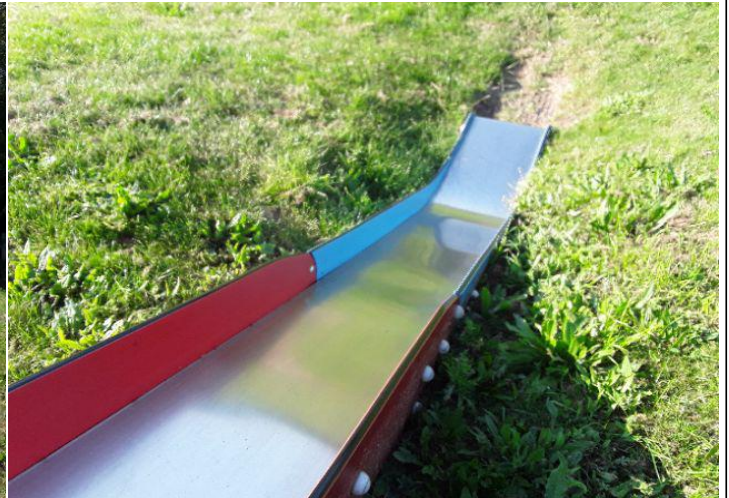
Finding: There are a number of dents in the slide surface

Action: Monitor for any further deterioration and repair as required

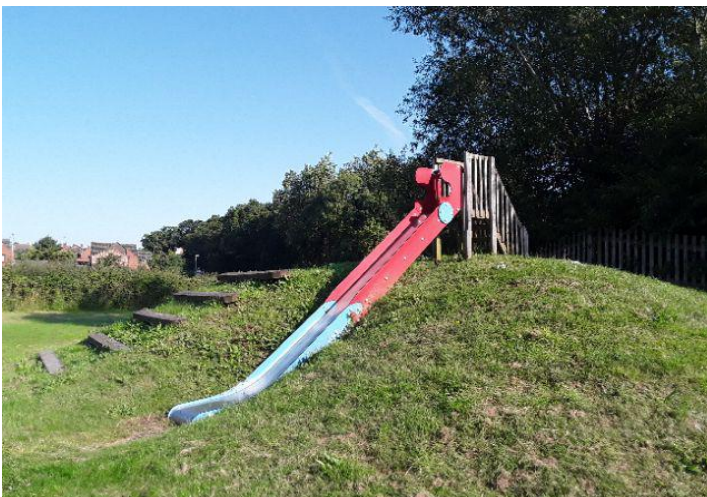
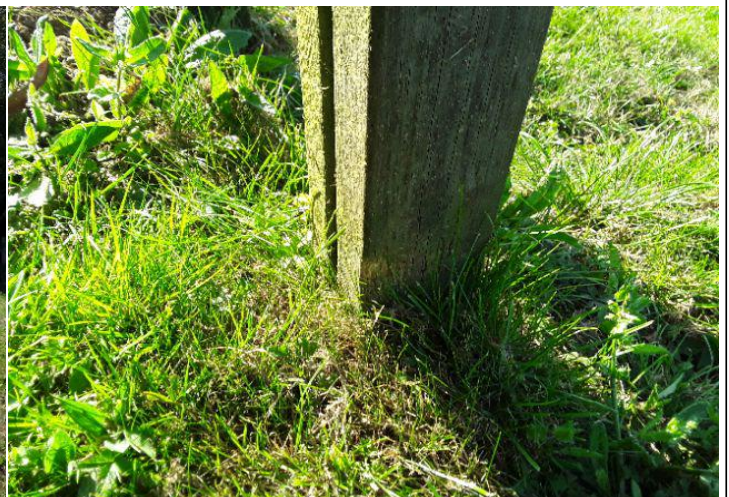
Finding: There is some strimmer / machinery damage apparent on the posts, this can penetrate the preservative applied to the timber and accelerate the rotting process

Action: Monitor for any deterioration (rot) and replace as required

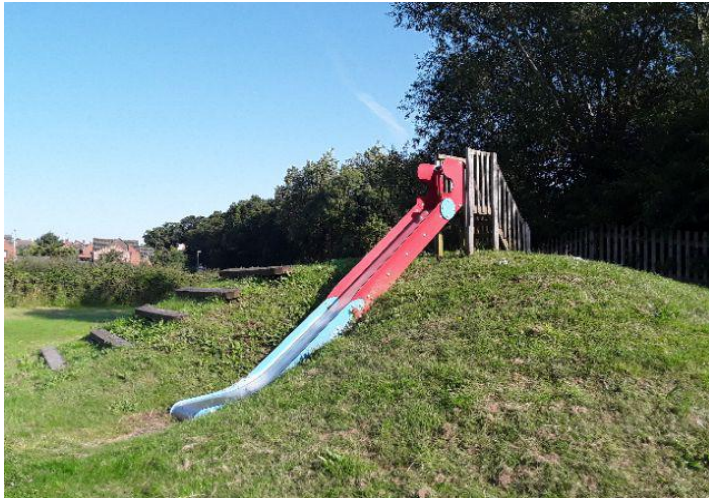
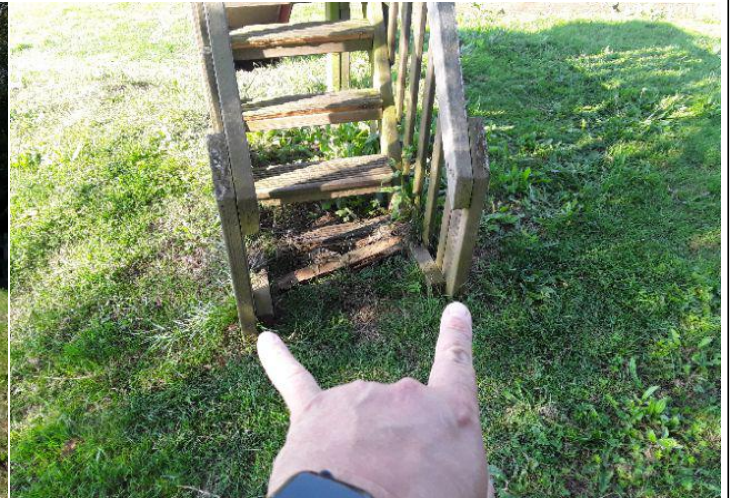
Finding: The item is loose in its foundations

Action: Reinstall item to secure

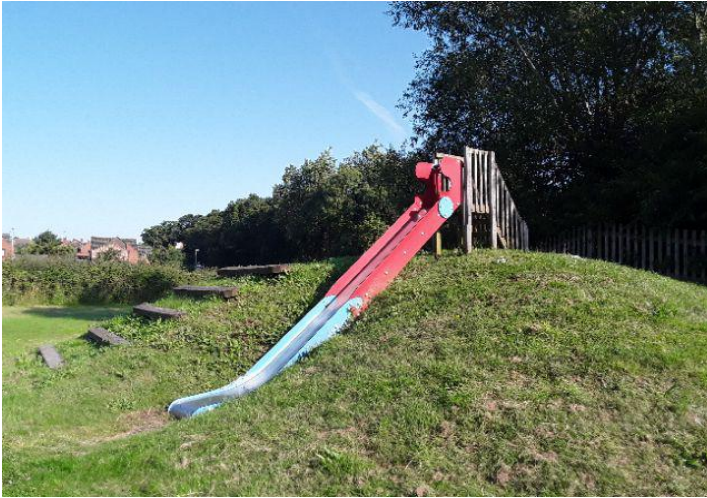
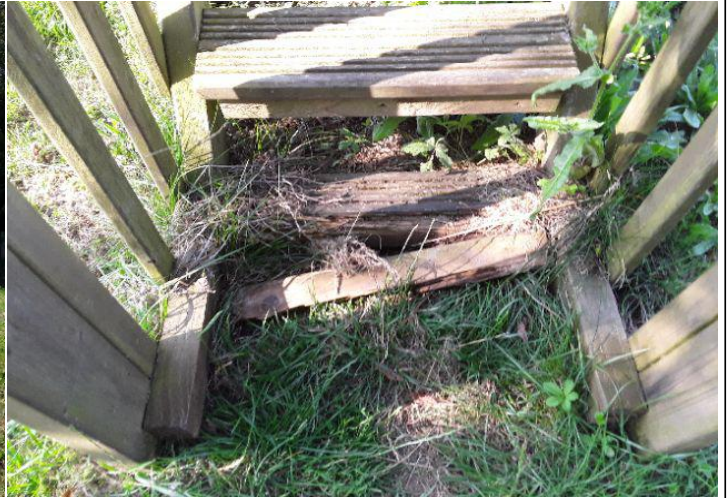
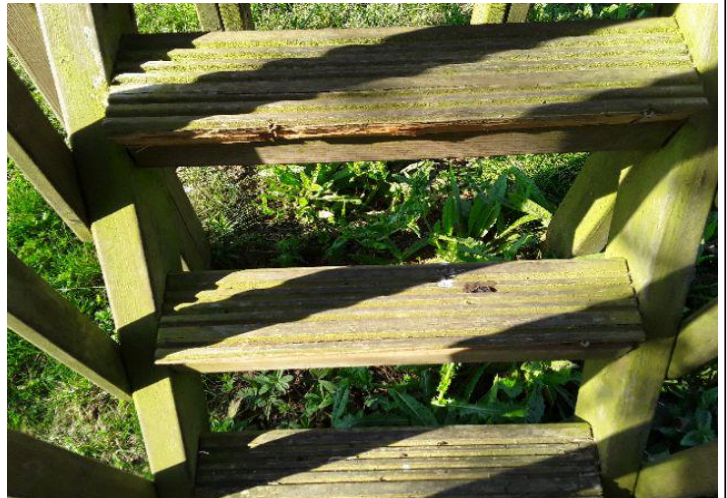
Finding: There are areas or parts of the timber steps that have rotted

Action: Replace all affected timbers

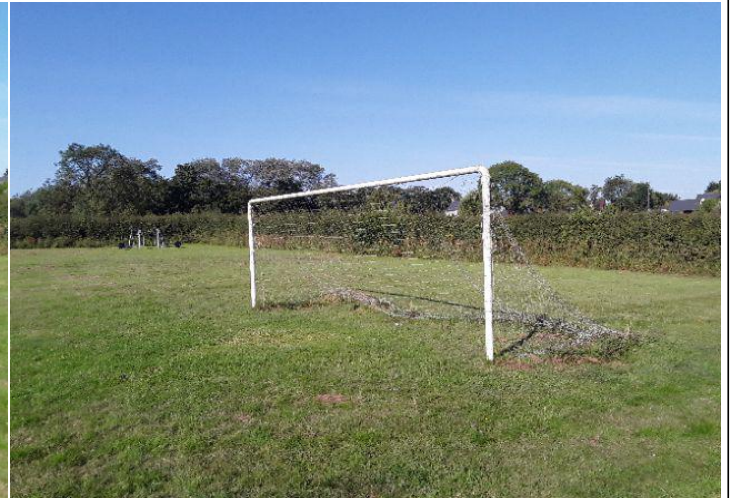
Finding: NB: We have undertaken a maintenance inspection only of the football goal(s); full load testing falls outside the scope of our inspection.

Action: Implement load testing as required

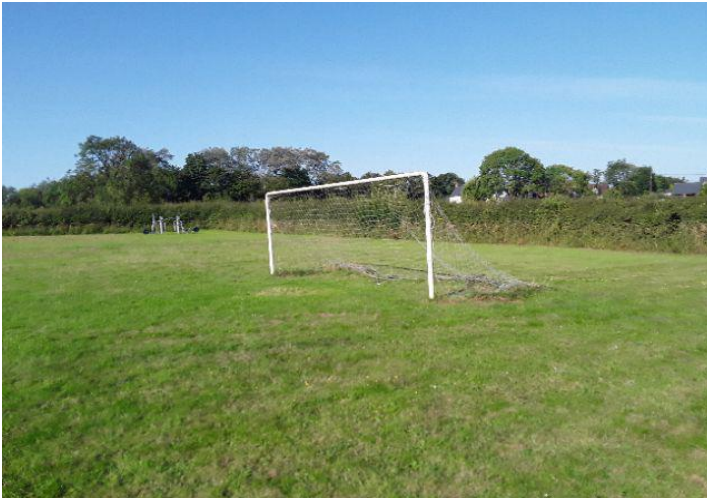
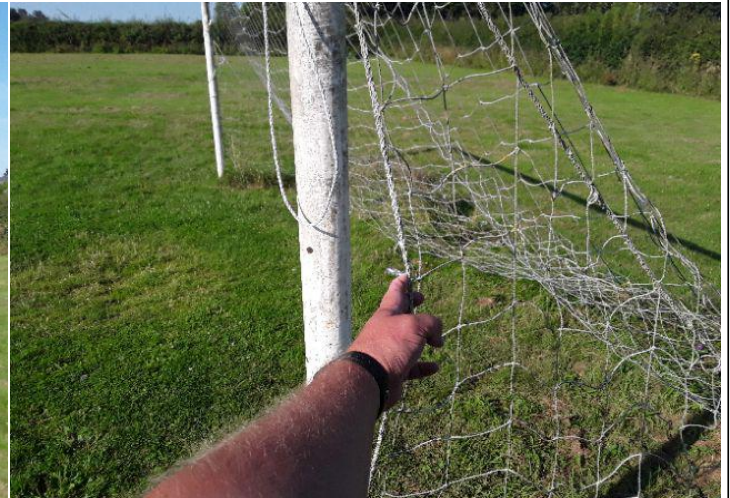
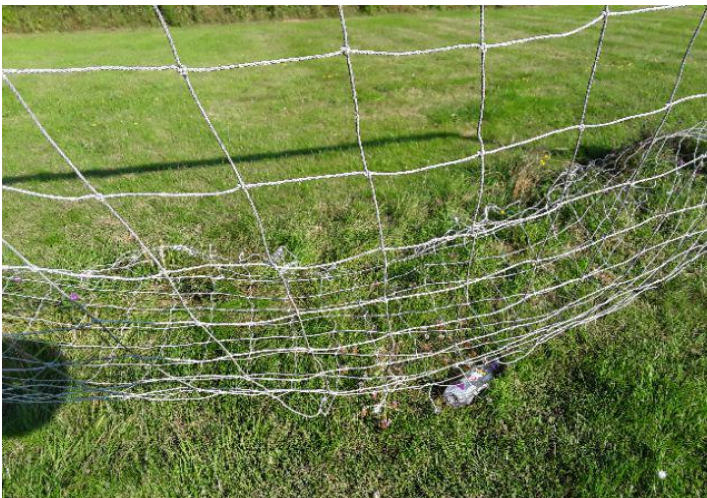
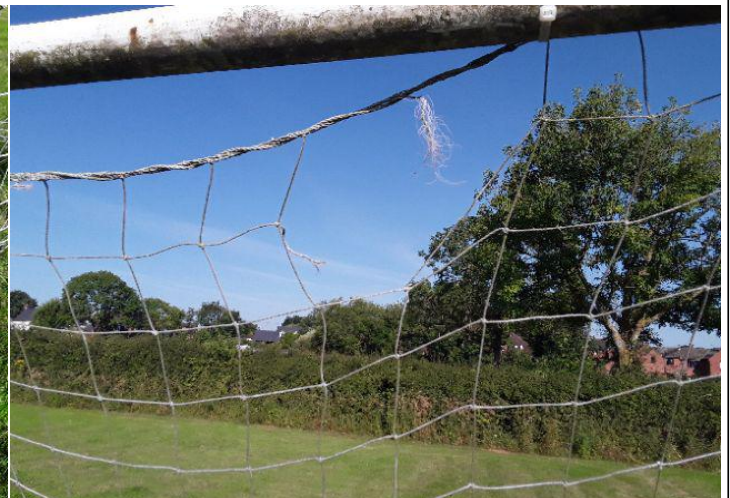
Finding: The goal netting isn't securely fixed to frame and surface

Action: Secure and repair the netting

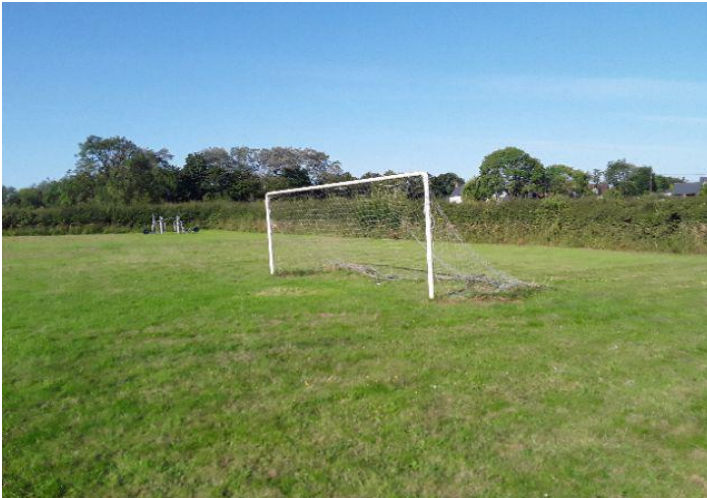
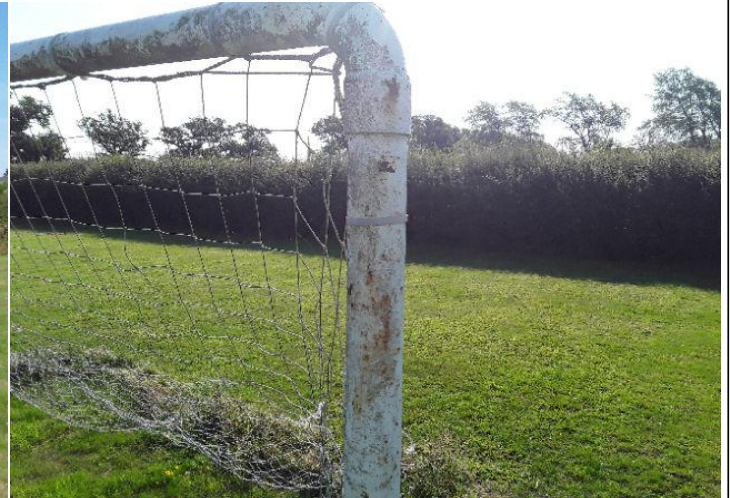
Finding: The paintwork on this item has been damaged or worn exposing the metal underneath which is rusting / corroding

Action: Treat affected areas and repaint

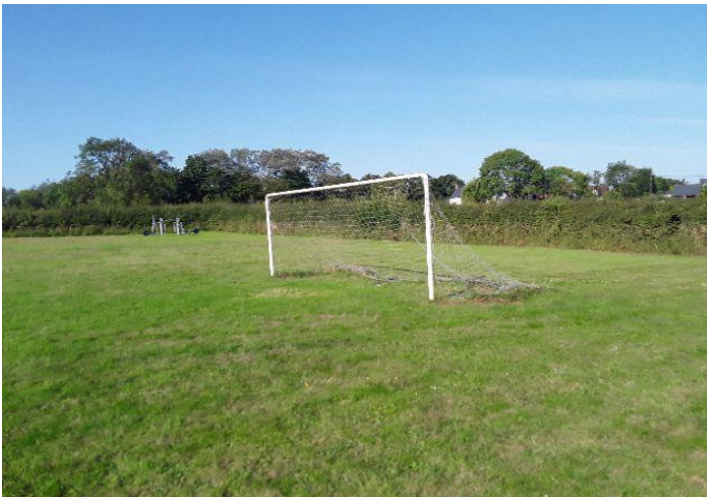
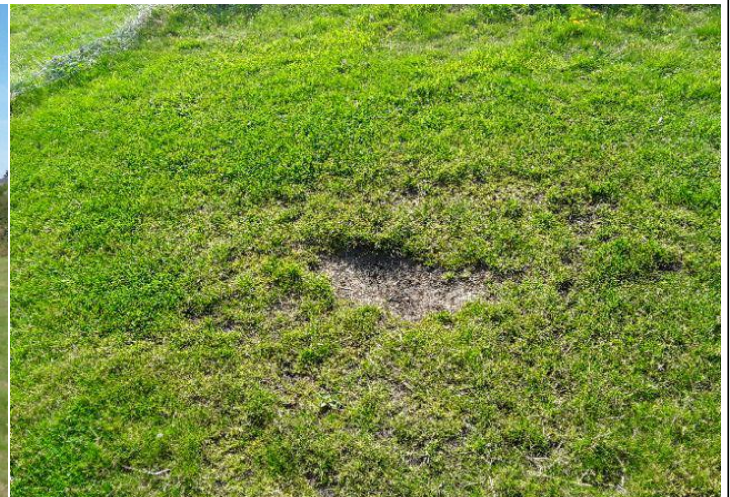
Finding: The surface has eroded in some areas and may be slippery in wet conditions

Action: Reinststate the surface
