Annual Inspection

Whaddon Parish Council

Whaddon Play Area
Shenley Road, Milton Keynes , MK17 0LW

Inspection Ref: 2432078

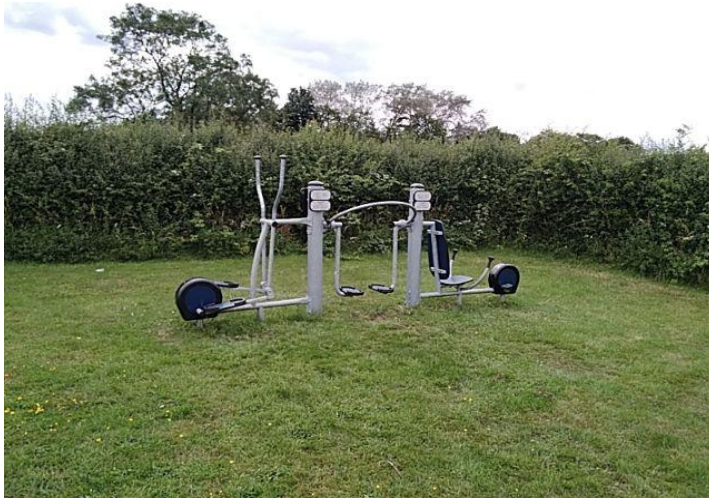
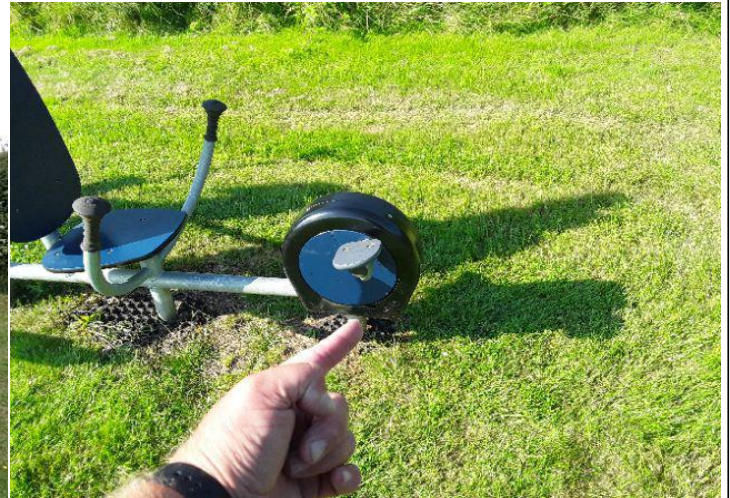
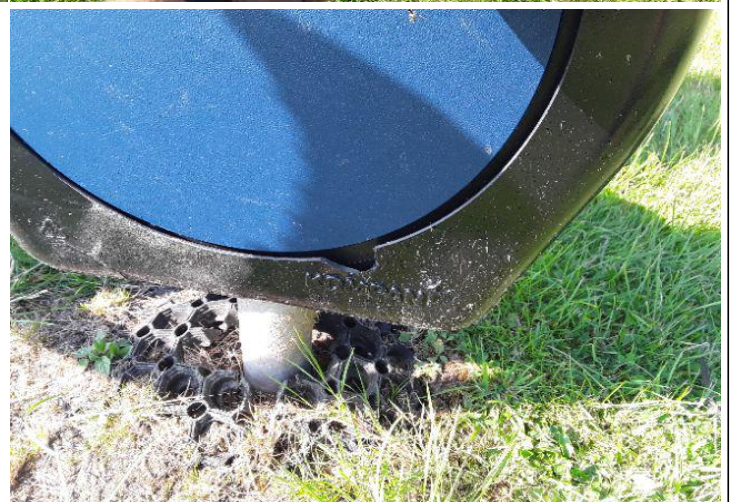
Finding: The cover has been damaged

Action: Monitor for any further deterioration and replace as required

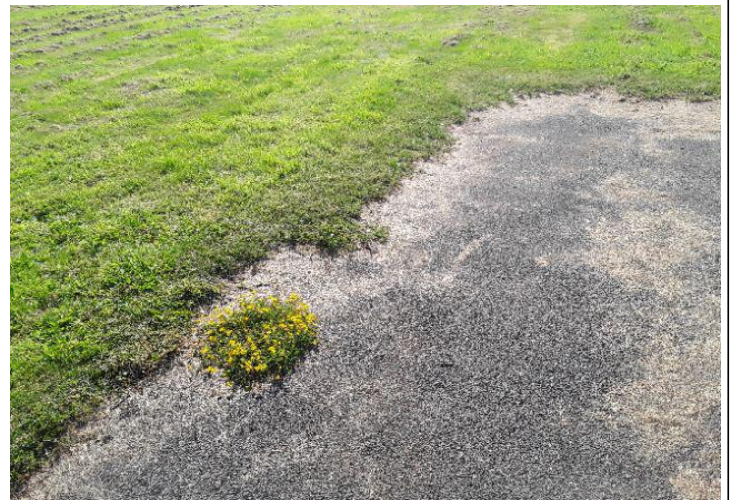
Finding: There is weed / vegetation growth on, between, or around the edges of the surfacing
Action: Remove weed / vegetation growth

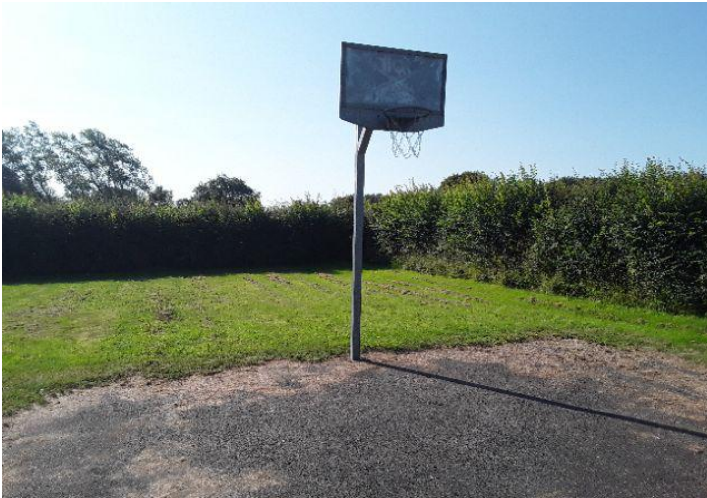
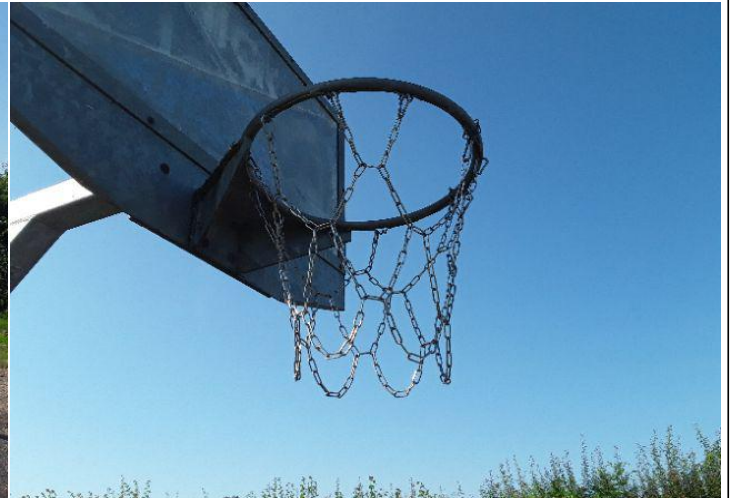
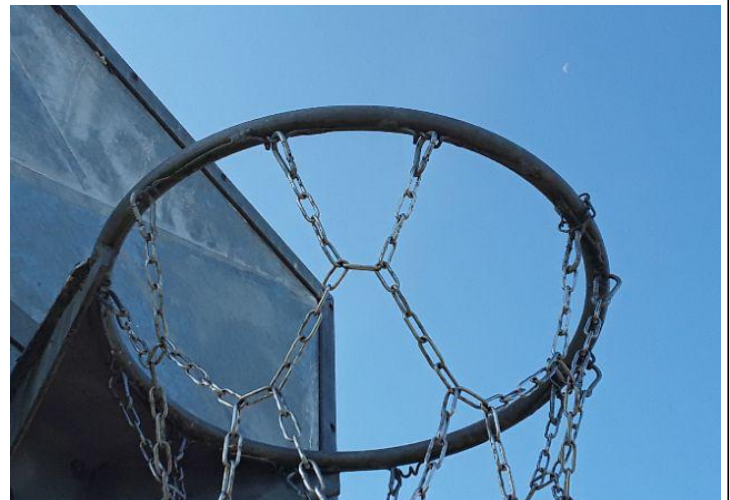
Finding: Inappropriate fittings have been used on the hoop netting which is creating multiple finger entrapments in contravention of BS EN 15312

Action: Replace with manufacturer spec hoop netting
