Annual Inspection

Whaddon Parish Council

Whaddon Play Area
Shenley Road, Milton Keynes , MK17 0LW

Inspection Ref: 2432078

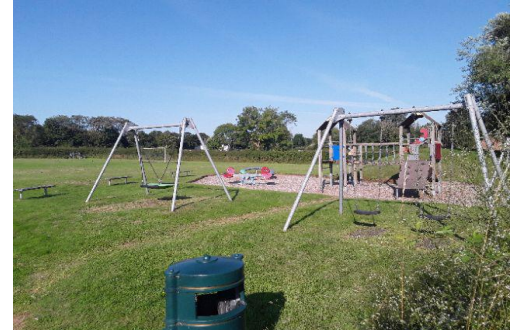
Item: Site General
Manufacturer: Owner/Operator
Surface Type: N/A
Item Quantity: 1
Equipment Compliance: N/A
Surface Area Compliance: N/A

There is weed / vegetation growth on, between, or around the edges of the surfacing - Remove weed / vegetation growth

The depth of the loose fill surfacing is lower than the recommended depth specified in BS EN 1176; the free height of fall of the equipment is less than 2.0m and a minimum of 300mm depth should be provided (including an extra 100mm to allow for compaction and displacement as per BS EN 1176 Part 1 - Table 4) - Top up loose fill surfacing to recommended levels

There are areas or parts of the timber edging that have rotted - Replace all affected timbers

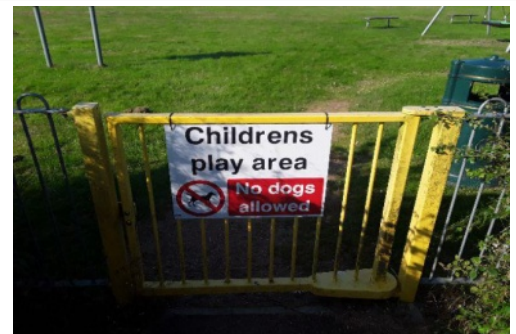
Item: Gate - Self Closing
Manufacturer: I.A.E. Fencing
Surface Type: Crushed Stone
Item Quantity: 1
Equipment Compliance: N/A
Surface Area Compliance: N/A

This item is satisfactory - no work required -

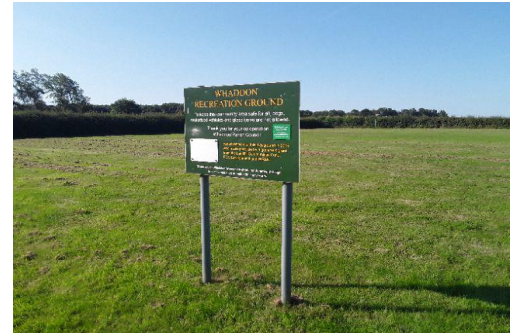
Item: Sign
Manufacturer: Owner/Operator
Surface Type: Grass
Item Quantity: 1
Equipment Compliance: N/A
Surface Area Compliance: N/A

The item has been damaged - Monitor for any further deterioration and replace as required

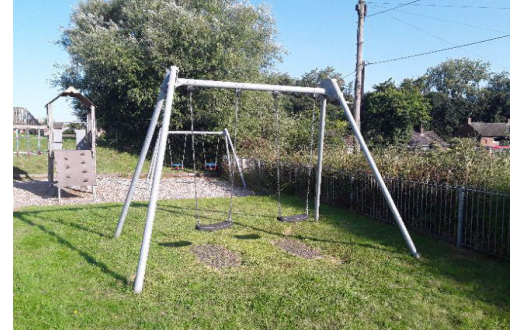
Item: 1 Bay 2 Seat (Flat)
Manufacturer: Kompan Ltd
Surface Type: Grass Matrix Tiles
Item Quantity: 1
Equipment Compliance: Yes
Surface Area Compliance: Yes

There is/are inserts missing - Replace missing inserts

There is some notable evidence of chain wear - Monitor for any further deterioration and replace when 40% worn

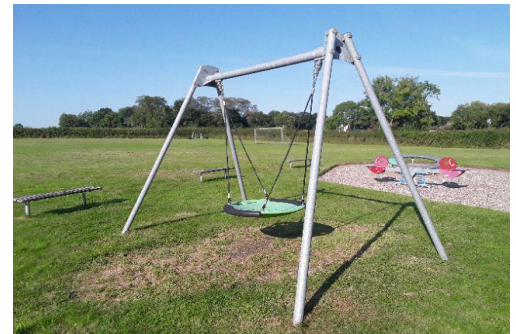
Item: Basket Swing - Type 1
Manufacturer: Kompan Ltd
Surface Type: Grass Matrix Tiles
Item Quantity: 1
Equipment Compliance: No
Surface Area Compliance: Yes

The connecting links are in excess of 8.6mm and less than 12mm and fail the requirements of BS EN 1176 Part 1; clause 4.2.13, Chains - Monitor - No remedial work recommended

There is some notable evidence of chain wear - Monitor for any further deterioration and replace when 40% worn

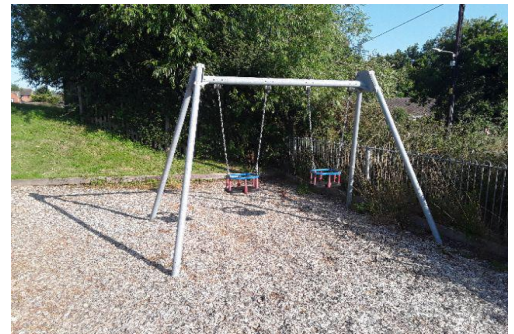
Item: 1 Bay 2 Seat (Cradle)
Manufacturer: Kompan Ltd
Surface Type: Woodchip
Item Quantity: 1
Equipment Compliance: Yes
Surface Area Compliance: Yes

BS EN 1176 Part 2: Annex A makes a recommendation that fences or enclosures should be upto 1.50m from the edges of the swing seat to the sides, and subject to risk assessment, from the edge of the impact area. This is however, a low risk finding and no remedial action is recommended. - Monitor - No remedial work recommended

The swing seat connector is damaged and the chain is out of position - Repair or replace

There is some notable evidence of chain wear - Monitor for any further deterioration and replace when 40% worn

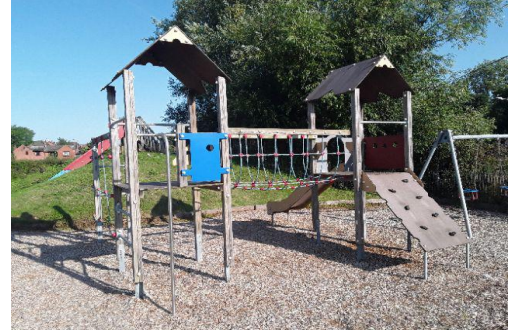
Item: Multi Play (Junior)
Manufacturer: Kompan Ltd
Surface Type: Woodchip
Item Quantity: 1
Equipment Compliance: No
Surface Area Compliance: Yes

The height of the slide runout is in excess of 350mm and does not meet the requirements of BS EN 1176: Part 3 - Top up loosefill to recommended levels

There are a number of dents in the slide surface - Monitor for any further deterioration and repair as required

There is or are fixings missing on the post shoes - Replace all missing fixings

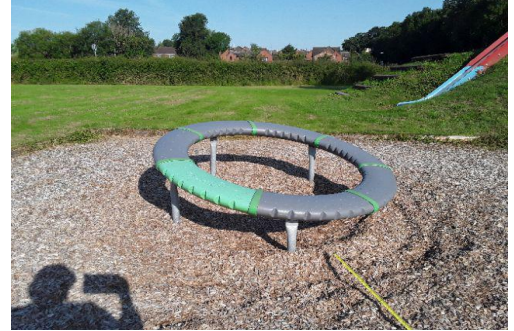
Item: Supernova
Manufacturer: Kompan Ltd
Surface Type: Woodchip
Item Quantity: 1
Equipment Compliance: No
Surface Area Compliance: Yes

The falling space overlaps the free space between the item and the supernova in contravention of the requirements of BS EN 1176:2017 Part 1 - Monitor - No remedial work recommended

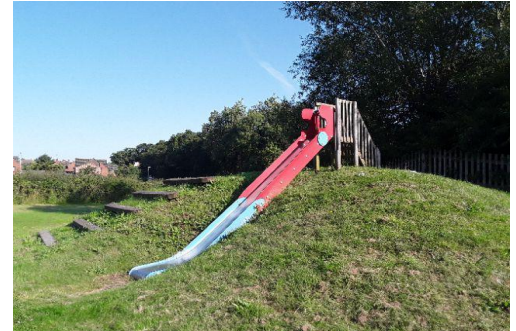
Item: Embankment Slide
Manufacturer: Kompan Ltd
Surface Type: Grass Matrix Tiles
Item Quantity: 1
Equipment Compliance: Yes
Surface Area Compliance: Yes

The timber has a number of splits/shakes or air cracks and this may affect the stability or allow water ingress which will accelerate the rotting process - Monitor to ensure the splits do not cross through fixing points of the structure and/or cause any instability

There is some strimmer / machinery damage apparent on the posts, this can penetrate the preservative applied to the timber and accelerate the rotting process - Monitor for any deterioration (rot) and replace as required

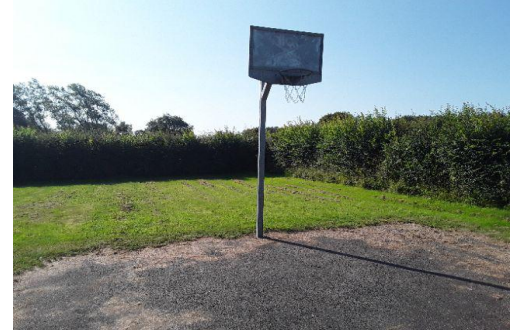
Item: Basketball Post
Manufacturer: Owner/Operator
Surface Type: Bitmac
Item Quantity: 1
Equipment Compliance: No
Surface Area Compliance: N/A

There is weed / vegetation growth on, between, or around the edges of the surfacing - Remove weed / vegetation growth

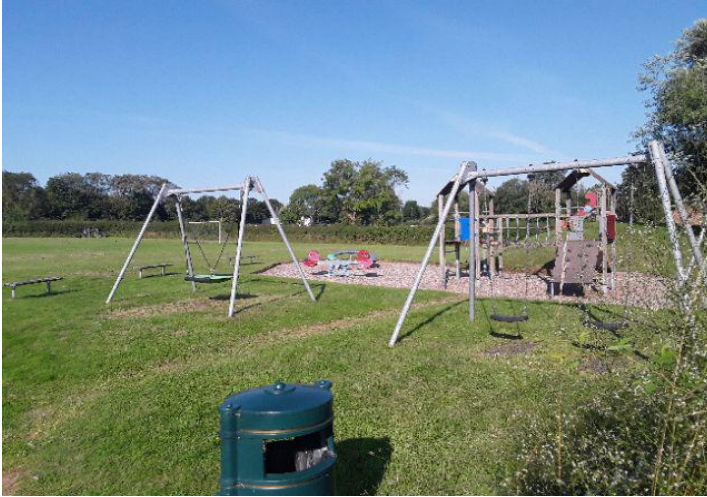
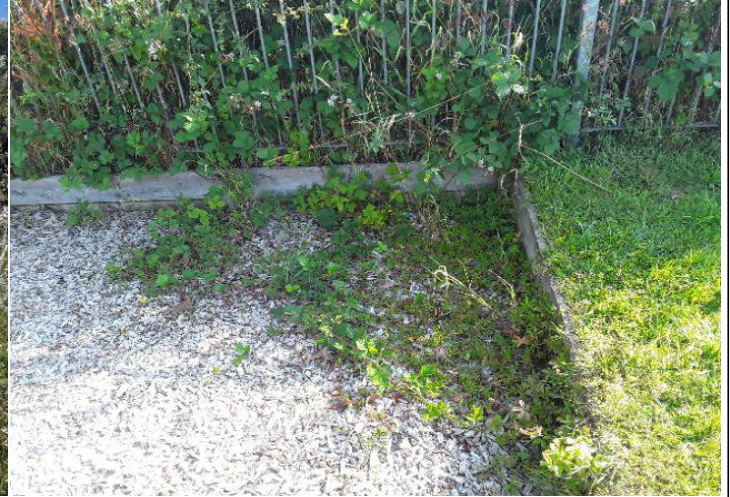
Item: Ancillary Items - Site General
Manufacturer: Owner/Operator

Finding: There is weed / vegetation growth on, between, or around the edges of the surfacing **Action:** Remove weed / vegetation growth

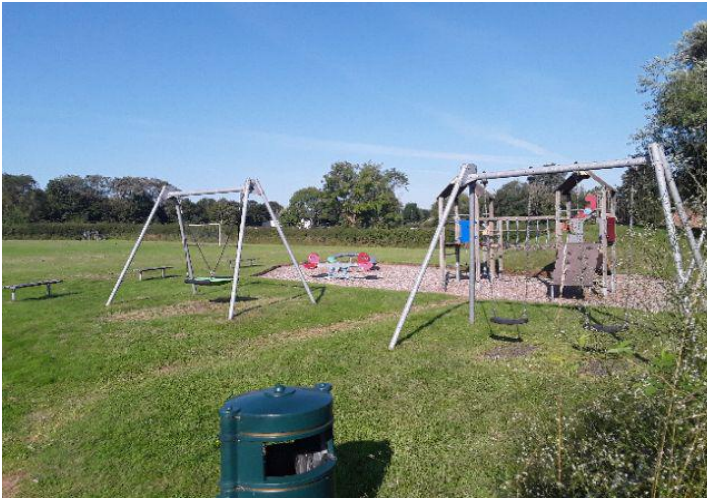
Item: Ancillary Items - Site General
Manufacturer: Owner/Operator

Finding: Signage should be provided for the outdoor fitness equipment in accordance with the requirements of BS EN 16630, key requirements of the sign include, but are not limited to, intended users, medical safety and emergency contact details
Action: Provide appropriate signage

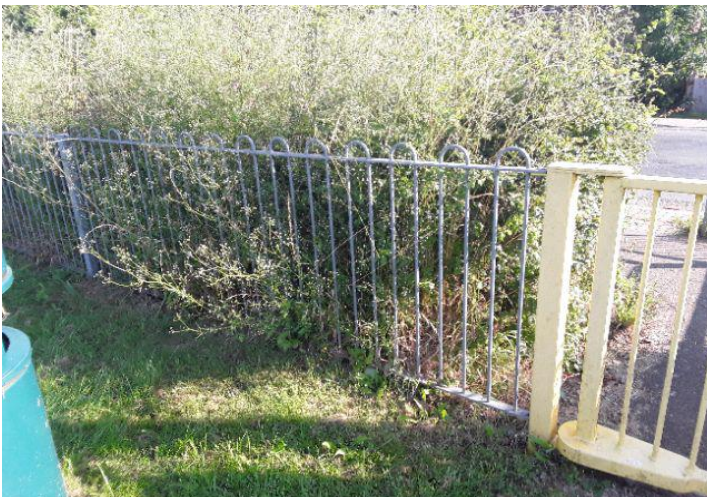
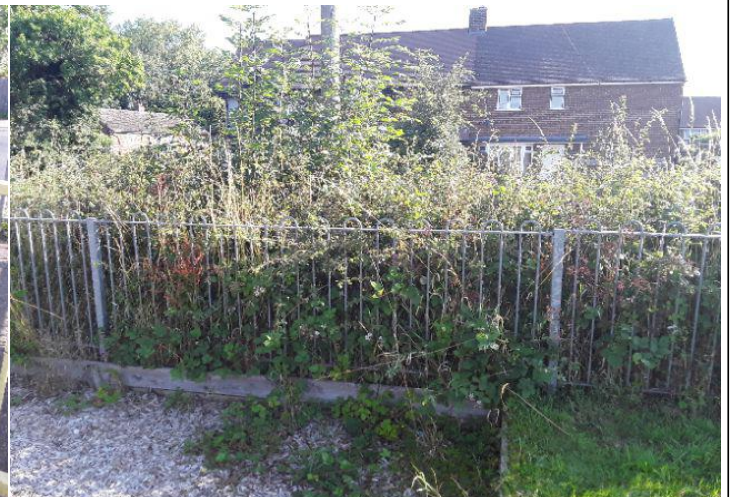
Item: Fences - Fence - Bow Top
Manufacturer: Outdoor Play People

Finding: The adjacent foliage is overhanging
Action: Cut back and maintain

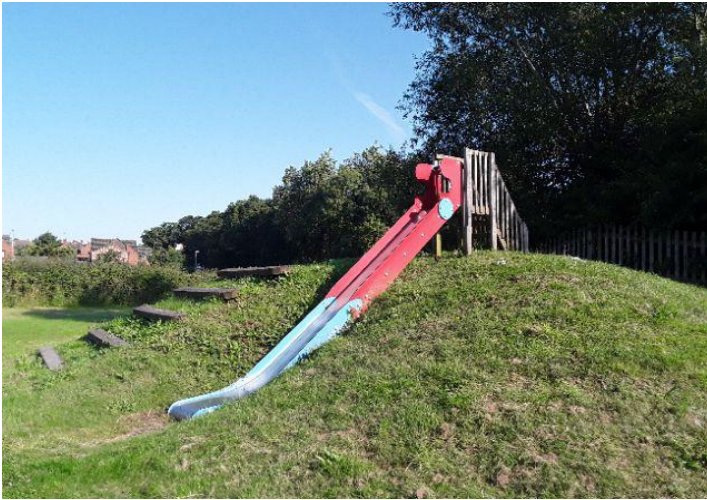
Item: Other - Embankment Slide
Manufacturer: Kompan Ltd

Finding: The steps protrude and are uneven creating trip points

Action: Reinststate the surrounding surface to remove trip points

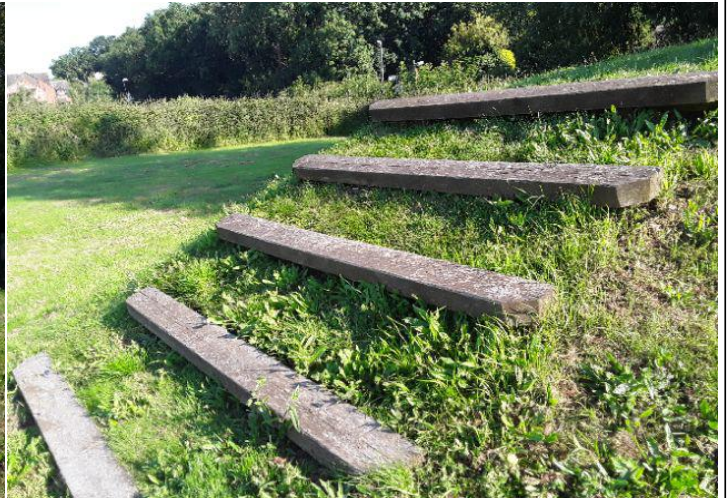
Item: Other - Embankment Slide
Manufacturer: Kompan Ltd

Finding: There is algae or moss on the surface of the equipment

Action: Clean and treat appropriately

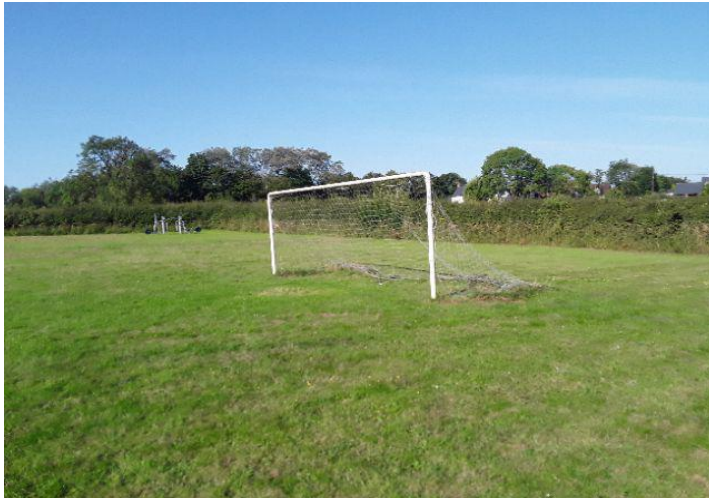
Item: Multi Use Games Area - Football Goal
Manufacturer: Owner/Operator

Finding: NB: We have undertaken a maintenance inspection only of the football goal(s); full load testing falls outside the scope of our inspection.

Action: Implement load testing as required

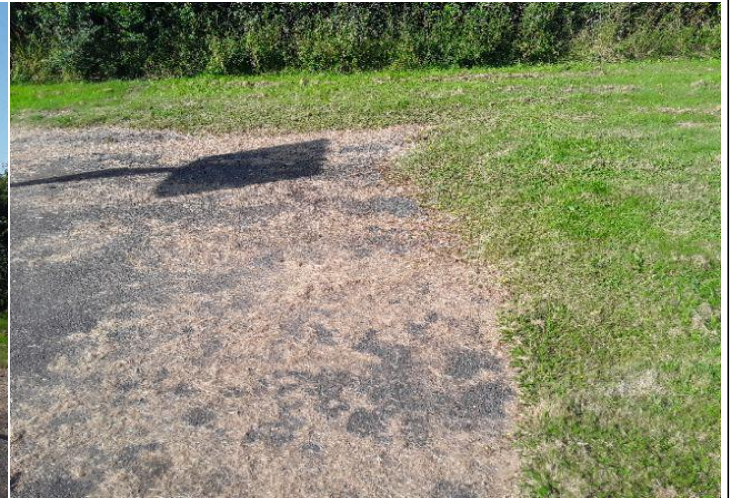
Item: Multi Use Games Area - Basketball Post
Manufacturer: Owner/Operator

Finding: There is weed / vegetation growth on, between, or around the edges of the surfacing
Action: Remove weed / vegetation growth
